Intensive Archeological Survey And Construction Monitoring For VFW Boulevard Drainage Improvements Segments 2, San Antonio, Bexar County, Texas

INTENSIVE ARCHEOLOGICAL SURVEY AND CONSTRUCTION MONITORING FOR VFW BOULEVARD DRAINAGE IMPROVEMENTS SEGMENT 2, SAN ANTONIO, BEXAR COUNTY, TEXAS

Cox | McLain Environmental Consulting, Inc. Archeological Report 034
(CMEC-AR-034)

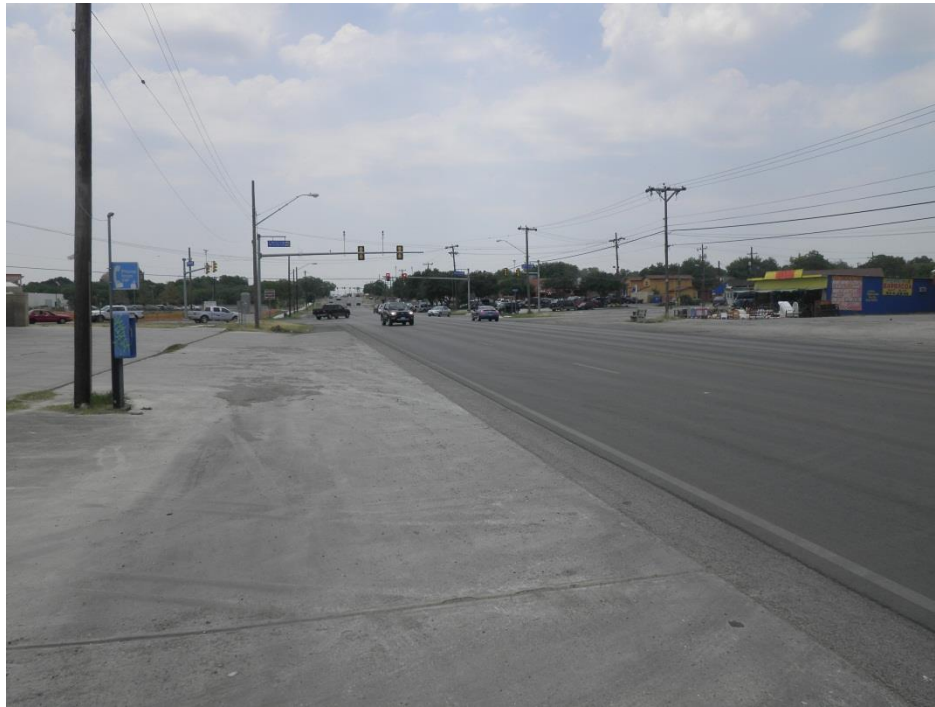
Figure 3. View south along Roosevelt Avenue to the VFW Boulevard intersection.

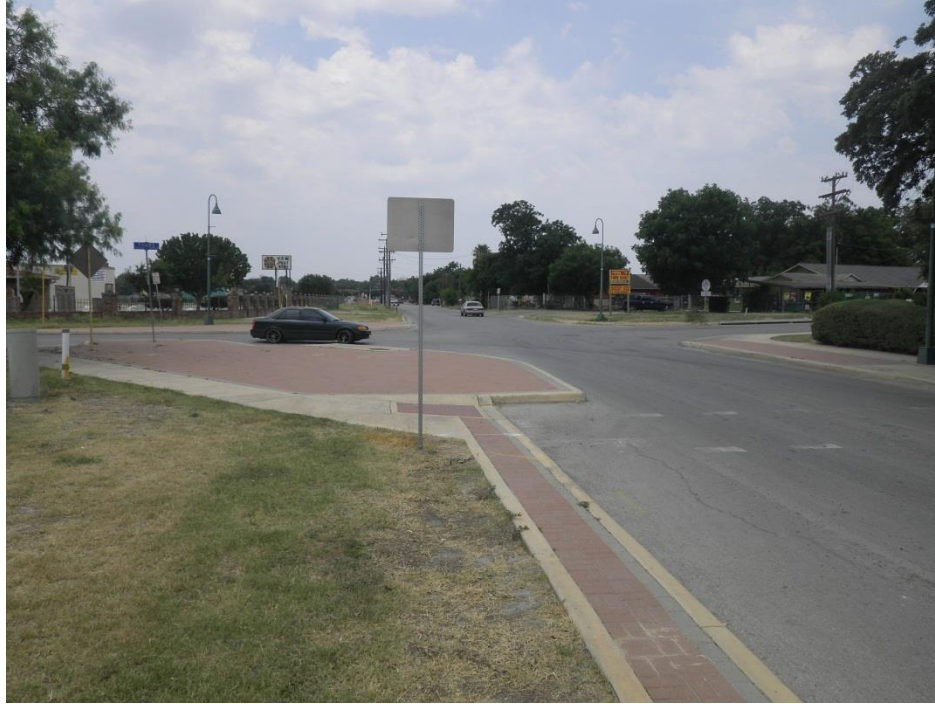
Figure 5. View southwest along the south side of VFW Boulevard from the east end of the APE, near the location of shovel test unit 13. The dark-colored car is traveling north on Padre Drive.

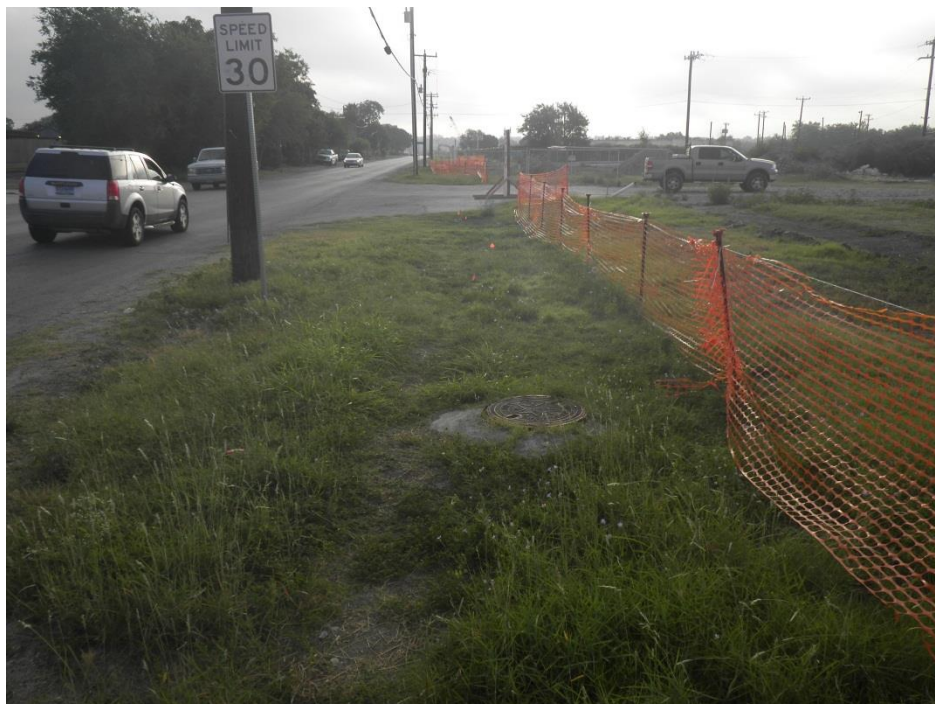
Figure 6. View northeast along the south side of VFW Boulevard from just east of the Roosevelt Avenue intersection, near the locations of backhoe units 1 and 2. Note manhole for sewer pipeline at center and safety fence for Mission Drive-In construction at right. A 16-inch high-pressure natural gas pipeline is located just to the right of the safety fence.

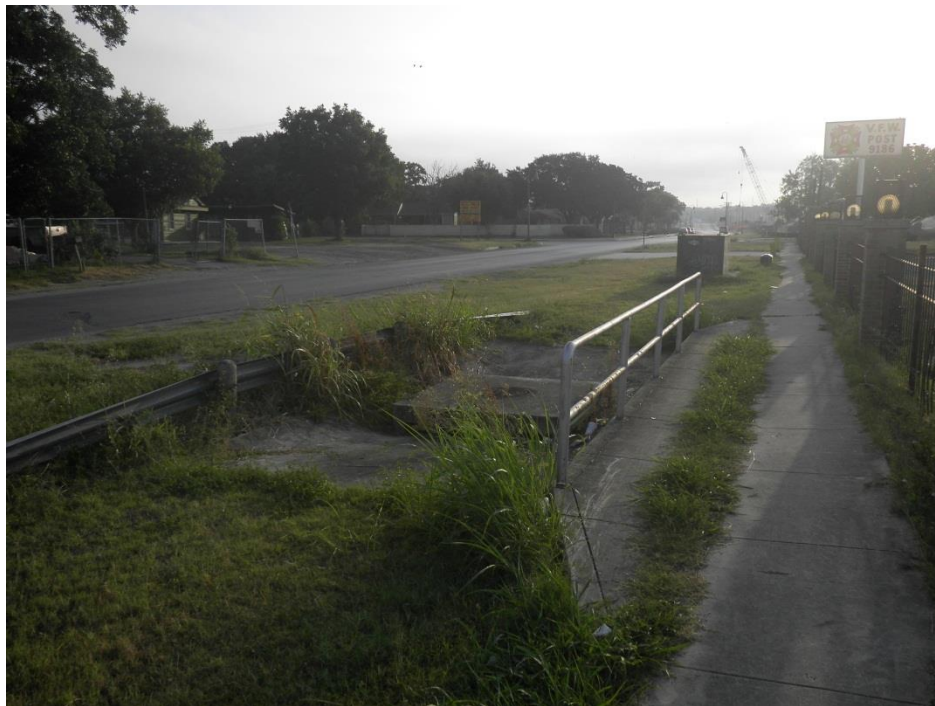
Figure 7. View northeast along south side of VFW Boulevard, just north of VFW Post 9186. The large rectangular object behind the drainage inlet and safety rail is an underground electric cable junction box. The large crane in the background at right is located in the construction zone for Segment 1.

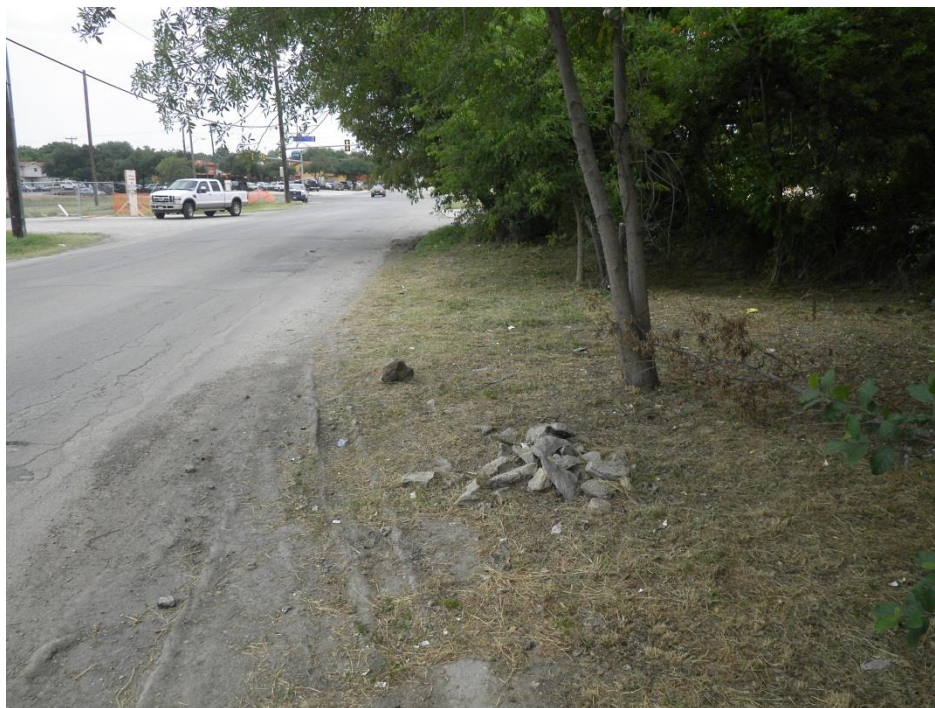
Figure 8. View southwest along the north side of VFW Boulevard, near the locations of shovel test units 6, 7, and 8.

Sixteen shovel test (ST) units were excavated in non-contiguous pockets of the APE where apparently undisturbed soil and/or vegetation was visible at the surface (see **Table 2** and **Figures 8 and 9**). Plastic bottle tops, fragments of foam cups, plastic bags, and other modern discarded items were found in units throughout the APE at up to 40 cm (16 in) in depth.

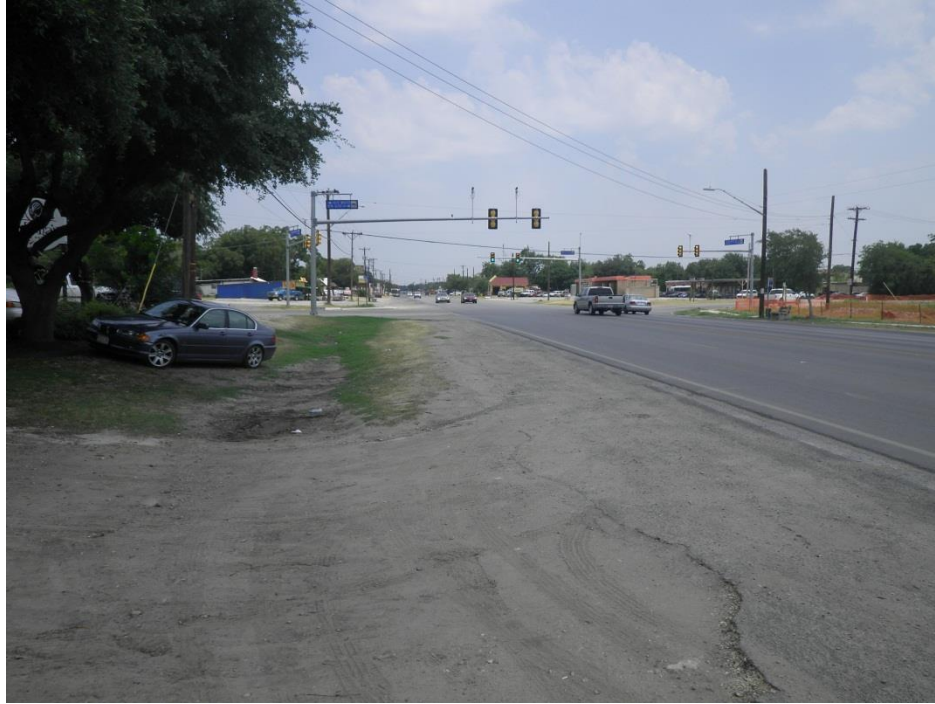
Figure 9. View north along Roosevelt Avenue to the VFW Boulevard intersection. Shovel test units 1 and 2 were excavated in the grassy area at center-left, mildly inconveniencing the driver of the BMW parked illegally at left.

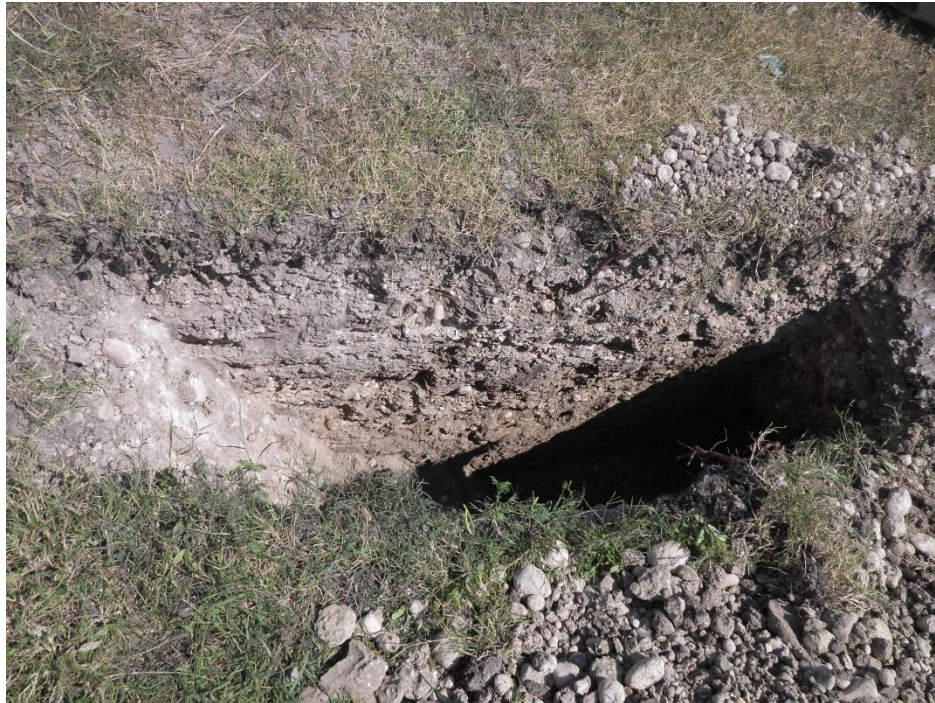
Figure 10. Representative trench view; view north at north wall of Trench 5. Note that approximately half of the 200-cm total depth consists of cobbly fill, and the remainder is the possible Pleistocene deposit shown in **Figure 12** and documented in Ahr and Ulrich 2012.

Overall, during survey investigations, CMEC archeologists noted that the Segment 2 APE was highly disturbed and that it likely contained thick deposits of fill, particularly in the vicinity of BHT 5, where the fill rests directly on deposits that may be Pleistocene in age. However, darker-colored, less-disturbed

Holocene loams were observed at depths ranging from 20 cmbs to 200 cmbs (8-79 in) in trenches along the length of the APE. No archeological materials or indications of an *acequia* were found during the survey.

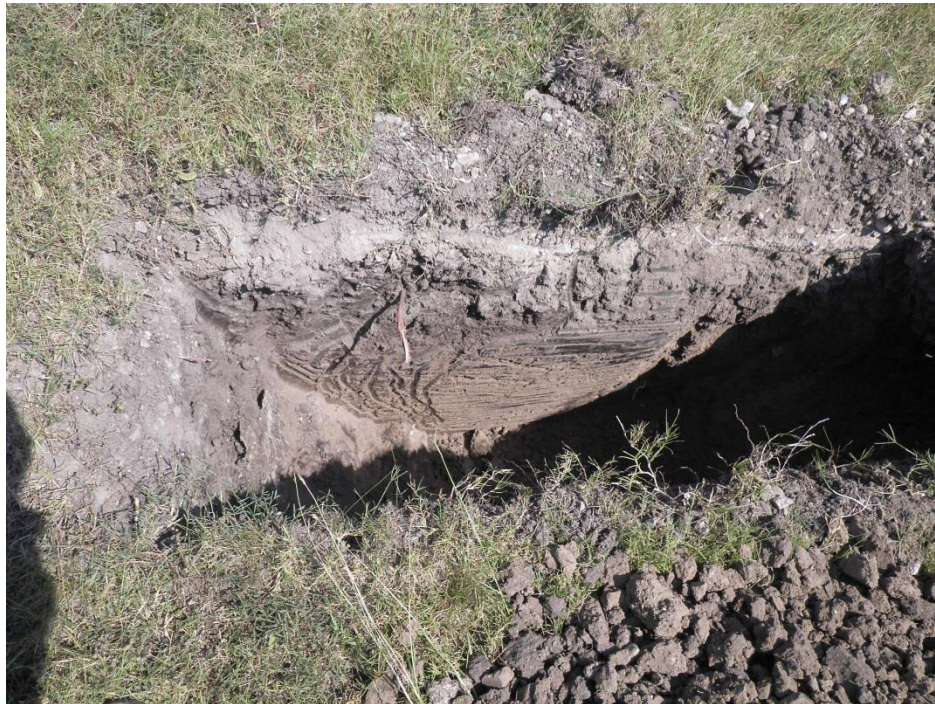
Figure 11. Representative trench view; view north at north wall of Trench 7. Total depth approximately 200 cmbs.

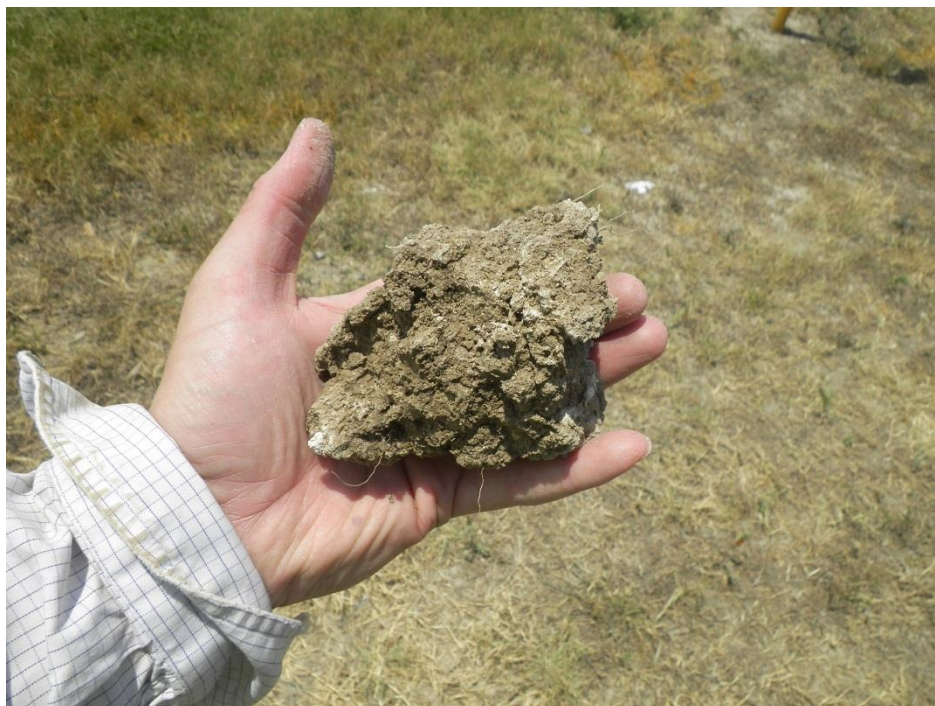
Figure 12. View down at sample of calcium-carbonate-rich silt loam found at 100-220 cmbs in trench units 5, 6, and 7. It appears to correspond to the Pleistocene terrace surface documented at 120-150 cmbs in the adjacent Segment 1 survey (Ahr and Ulrich 2012).

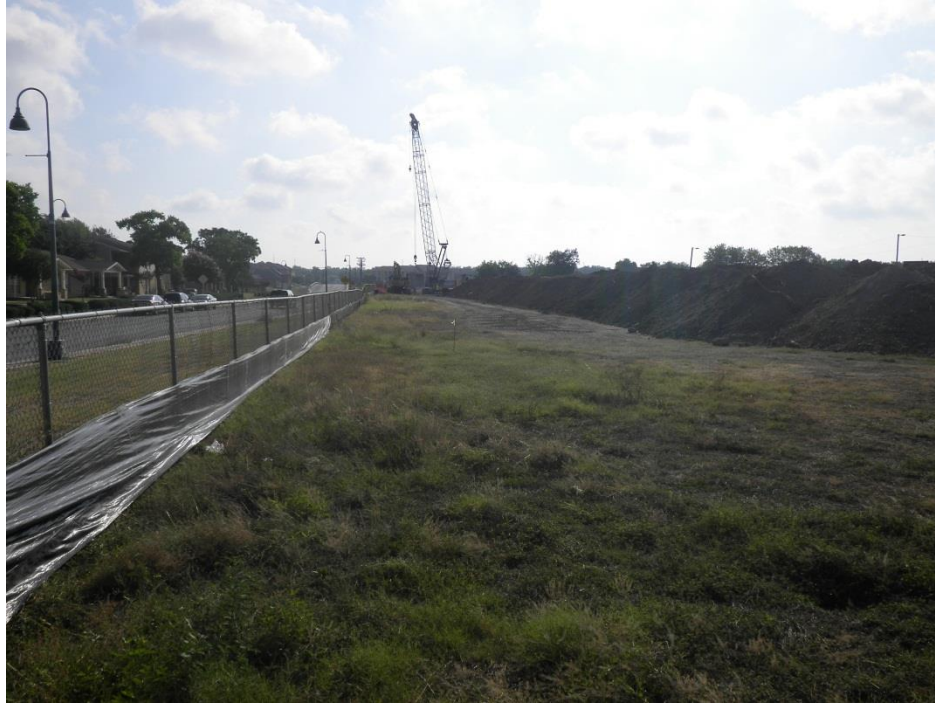
Figure 13. View northeast from the east end of the Segment 2 APE to Segment 1, under construction in mid-2012.

Seven backhoe trenches (BHTs) were excavated to depths of up to 220 cm or 2.2 m (87 in or 7.2 ft) (see **Table 3** and **Figures 10-12**). All were placed along the south side of VFW Boulevard due to the lack of sufficient open ground in the rest of the APE. The trenches were excavated with particular care due to the close proximity of multiple utility lines, especially 16-inch-diameter CPS Energy natural gas pipelines along both sides of VFW Boulevard and underground electrical cables on the south side (see **Figures 2** and **6**). With the exception of two truncated units (BHTs 3 and 4; see below), the trenches generally revealed layers of extremely hard cobbly/gravelly fill ranging from 15 cm to 100 cm (6 in to 39 in) in thickness over various less-disturbed loams and clay loams underlain by a siltier, calcareous, lighter-colored basal deposit (see **Figure 12**) that appears to correspond to the Ckk horizon and Pleistocene terrace surface identified by CAR-UTSA (Ahr and Ulrich 2012) in the adjacent Segment 1, which was under construction in mid-2012 (see **Figures 13** and **14**).

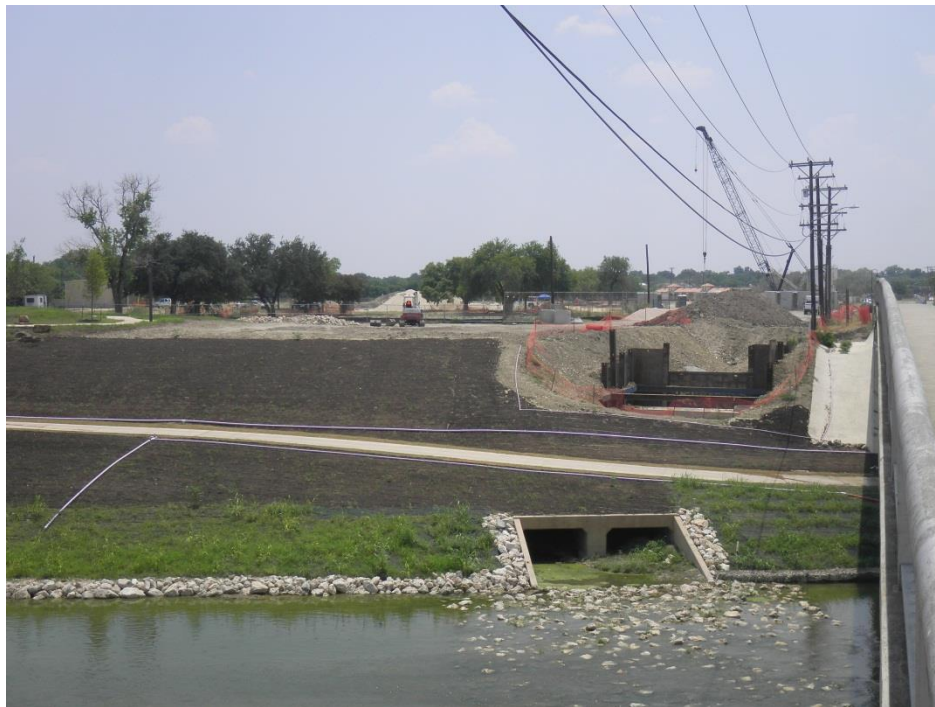
Figure 14. View southwest from the VFW Boulevard bridge over the San Antonio River to the Segment 1 construction zone.

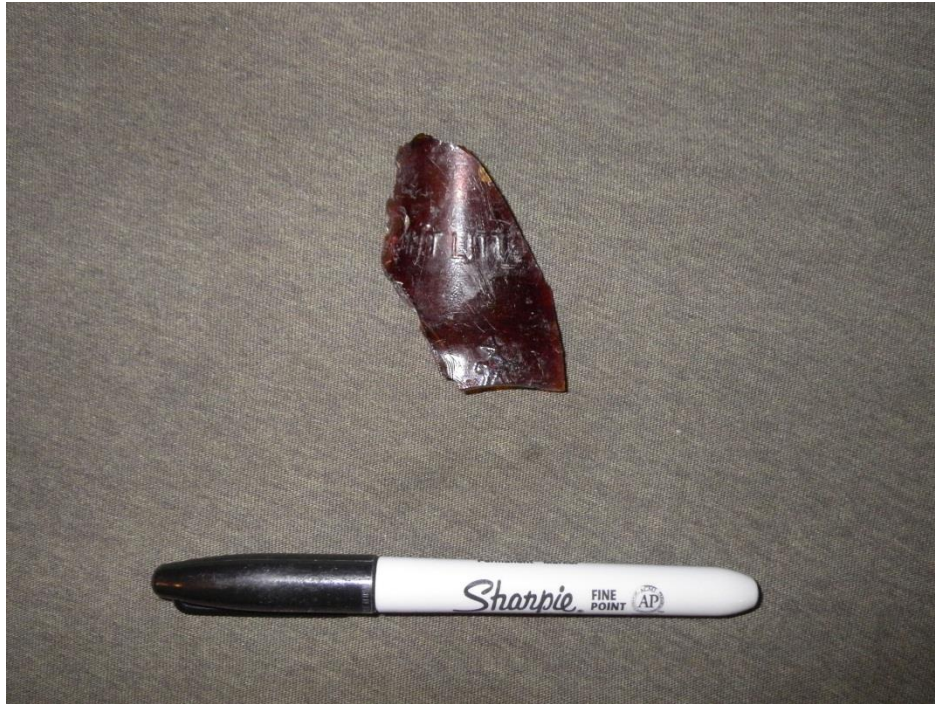
Figure 15. Beer bottle fragment with Anheuser-Busch logo and “Don’t Litter” message, indicating manufacture in the last several decades, found at nearly 100 cmbs in backhoe unit 5.

No materials of archeological interest were found in any of the trenches. Three units (see **Table 3**) contained modern materials such as beer bottle fragments and pieces of plastic pipe at 90-100 cm (35-39 in) in depth (see **Figure 15**).

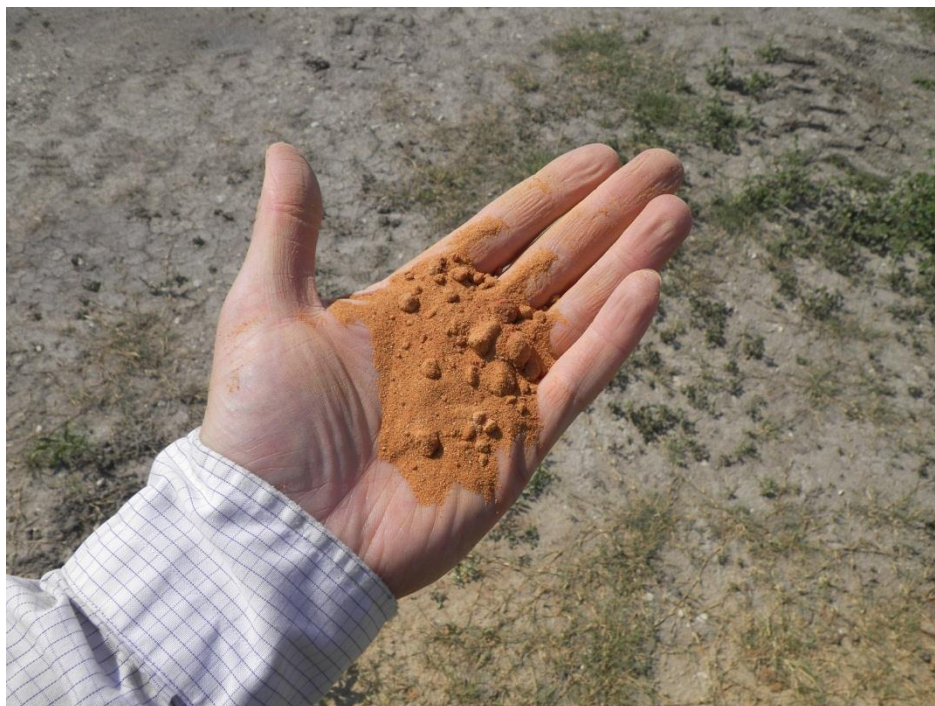
Figure 16. Fine sand construction/utility installation fill found at 70 cmbs in trenches 3 and 4. Both were terminated at that depth due to safety concerns.

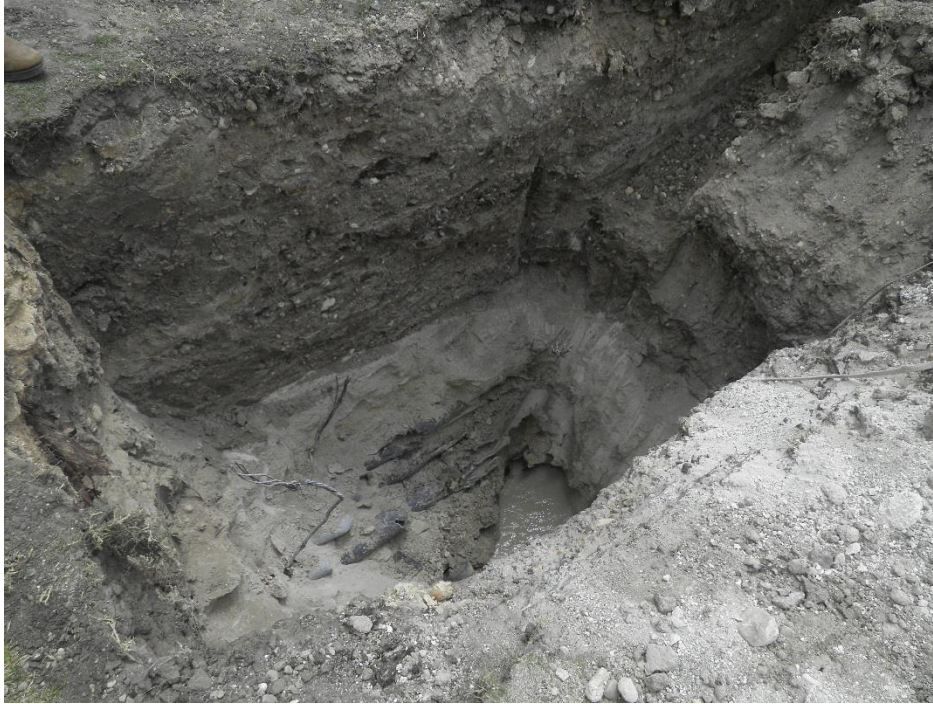
Figure 19. View southeast at 3-m-deep construction trench on south side of VFW near center of APE. Note layers of coarse fill at top and at least 6 deep utility lines (2 cables, 4 pipelines) at center.

During the monitoring phase, extensive subsurface disturbance was observed, primarily due to dozens of active and inactive utility lines (electrical, communications, gas, water, and wastewater) (see **Figures**

19-27) at depths of 1-6 m (0.9-20 ft). No materials or deposits of archeological interest were found, and the darker Holocene loams discussed above seen in survey-stage trenches now appear to represent rare pockets of less-disturbed soil rather than windows into typical subsurface conditions. No intact deposits were found at the projected *acequia* location (see **Figure 22**). Field forms are included in **Appendix A**.

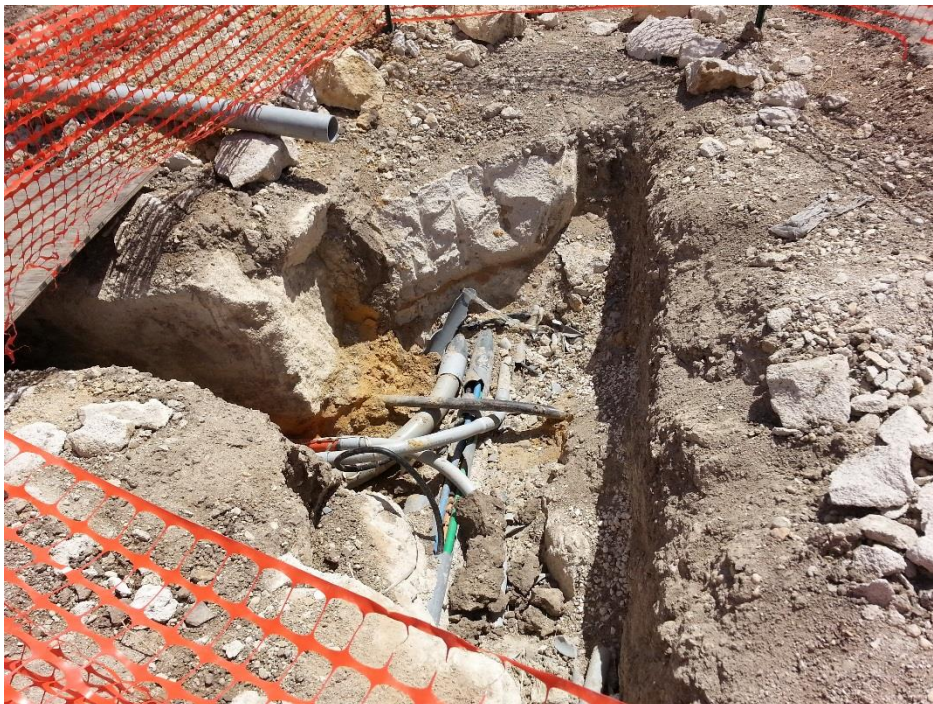
Figure 20. View east at typical residential utility lines in relatively shallow excavations (approximately 1.5 m in depth) along north side of VFW near east end of APE.

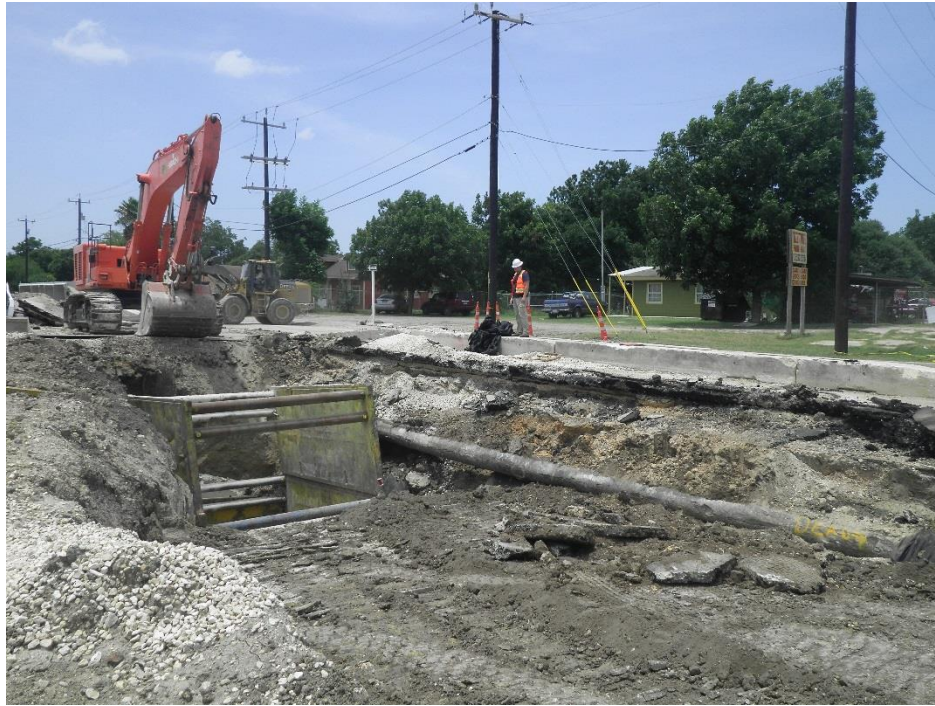
Figure 21. View northwest at large-scale, partially-shored excavations along south side of VFW just west of Padre. Note large existing pipeline at center-right, approximately 2.5 m in depth (monitor for scale at center).

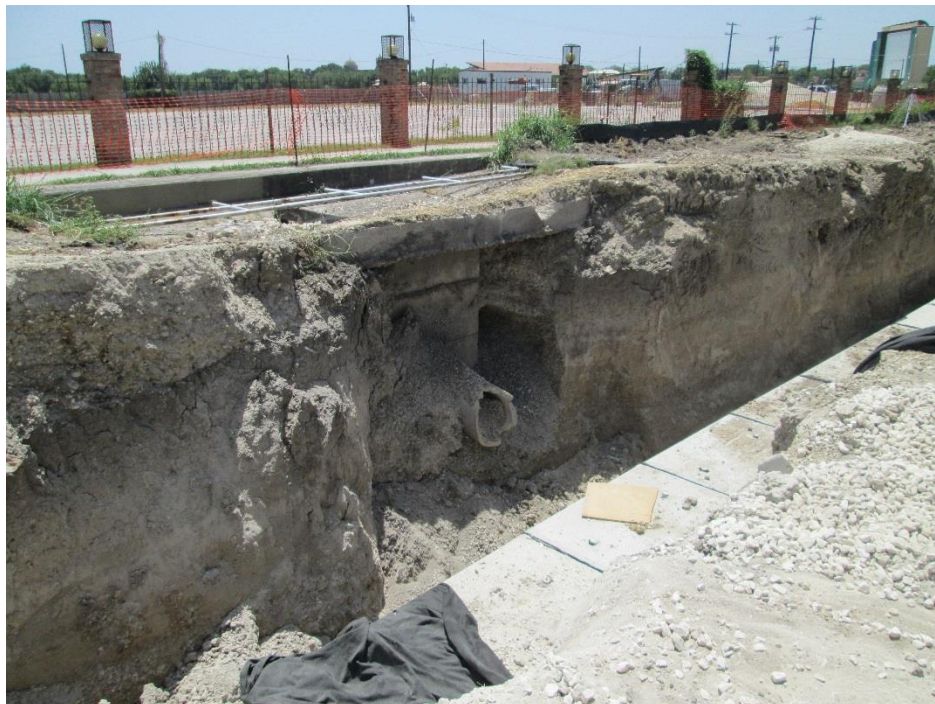
Figure 22. View southwest at previously constructed drainage structure at topographic low in predicted acequia location. Disturbed fill layers rest on apparent Pleistocene terrace material in this profile, which is approximately 3 m deep and 20 m in length.

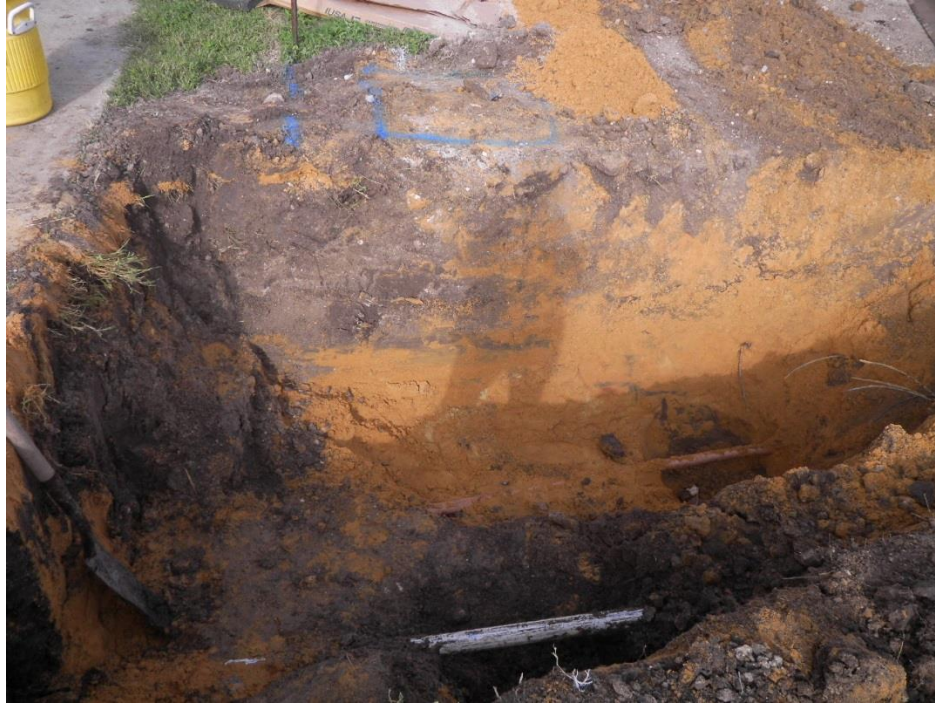
Figure 23. View west at 2-m-deep construction trench north of VFW Post property. Note pipelines and orange utility fill.

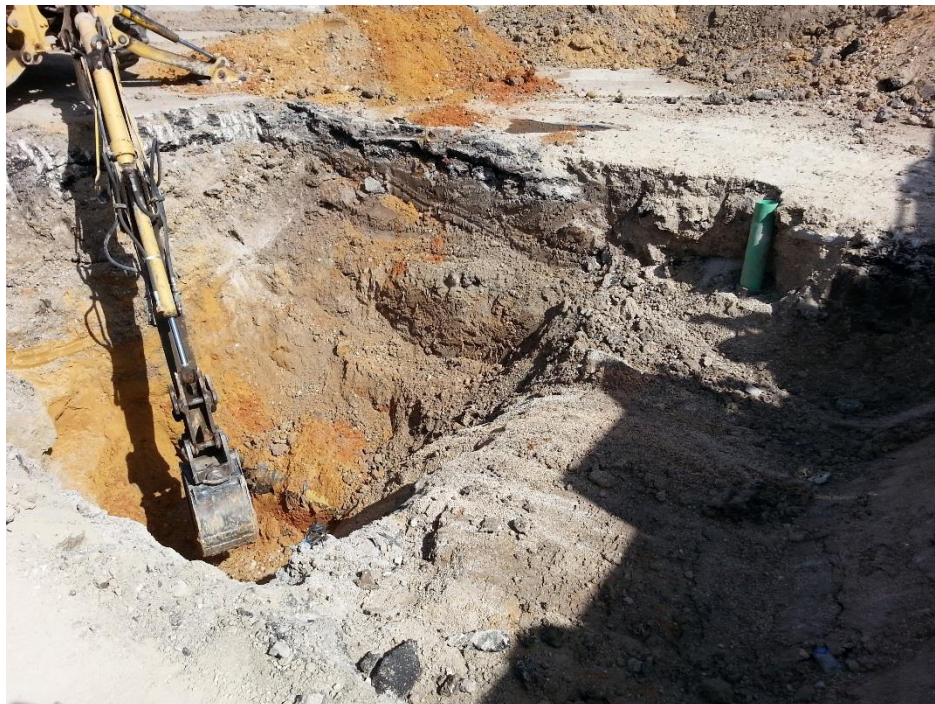
Figure 24. View of typical utility fill in 3-m-deep excavations on west end of APE.

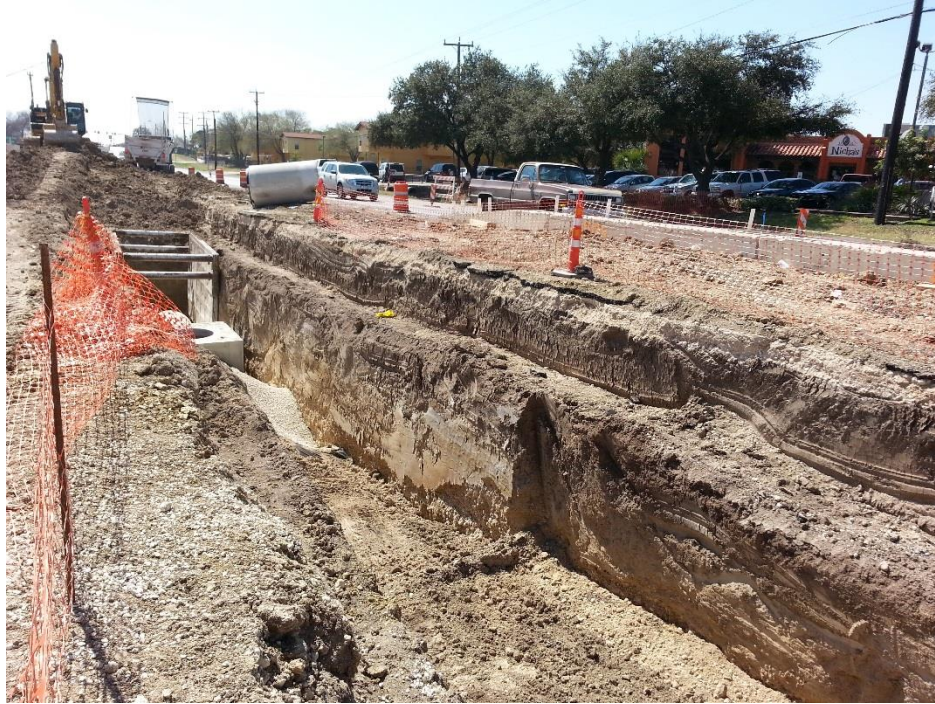
Figure 25. View south-southwest at 5-m-deep excavations along east side of Roosevelt at west end of APE.

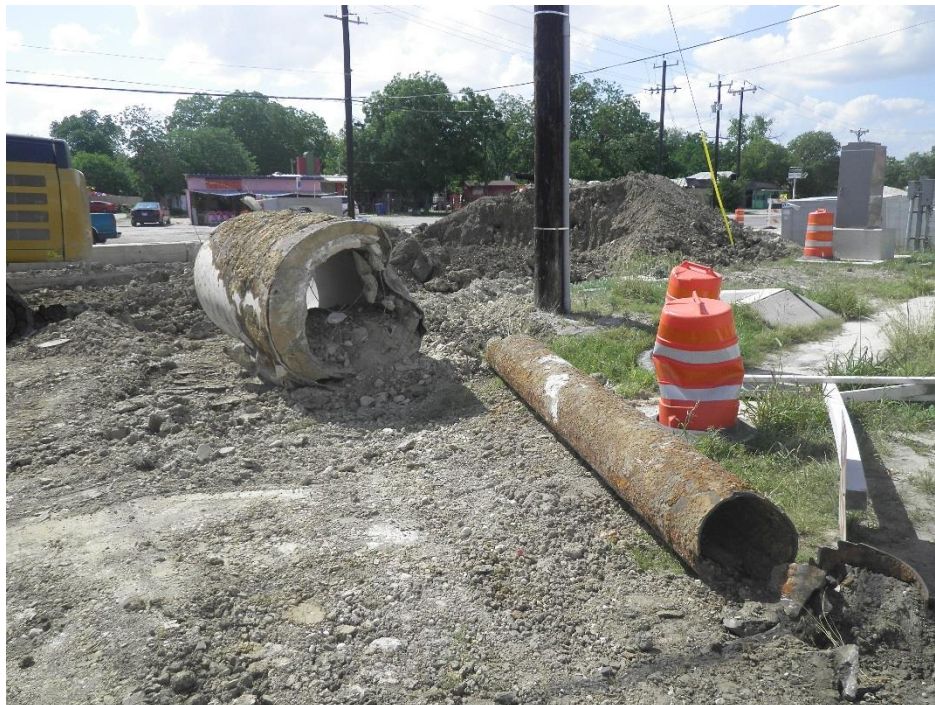
Figure 26. View northwest at segments of previous pipelines removed during construction. Photo taken at intersection of VFW and Roosevelt.

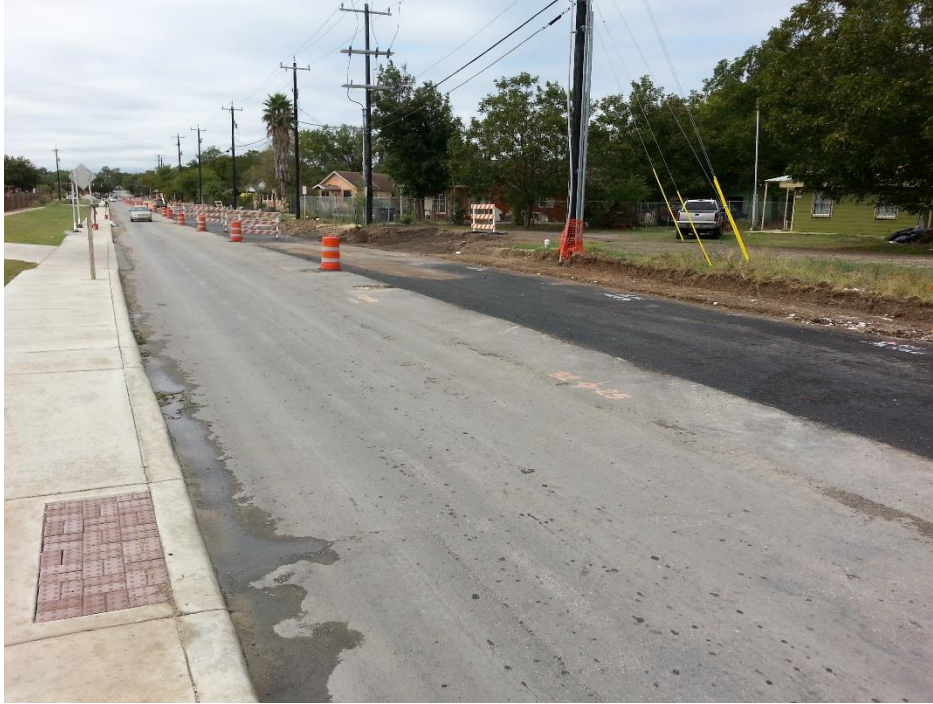
Figure 27. View west along VFW from near Padre in final stages of construction.
